Qualitative study of Kathmandu's traditional water spout (Hiti) system.

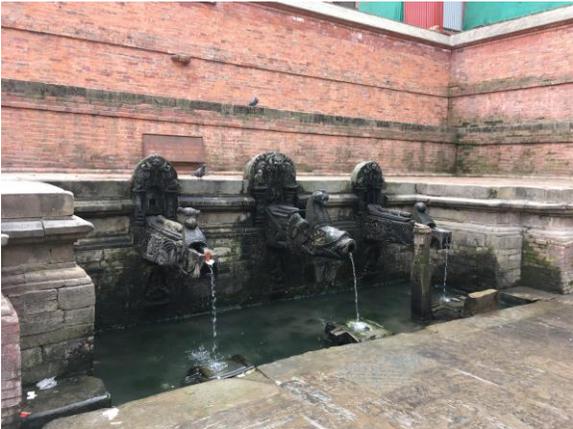
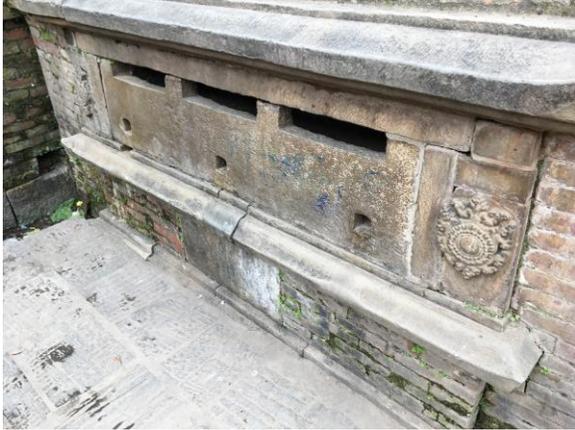
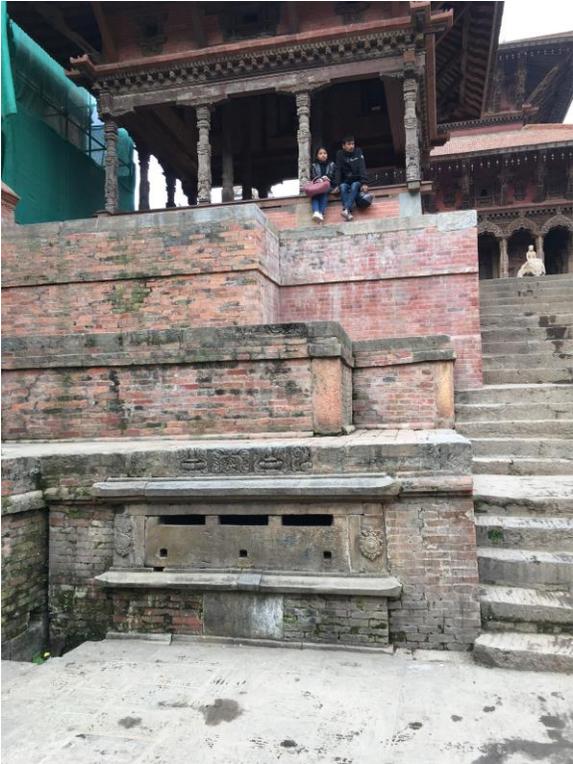
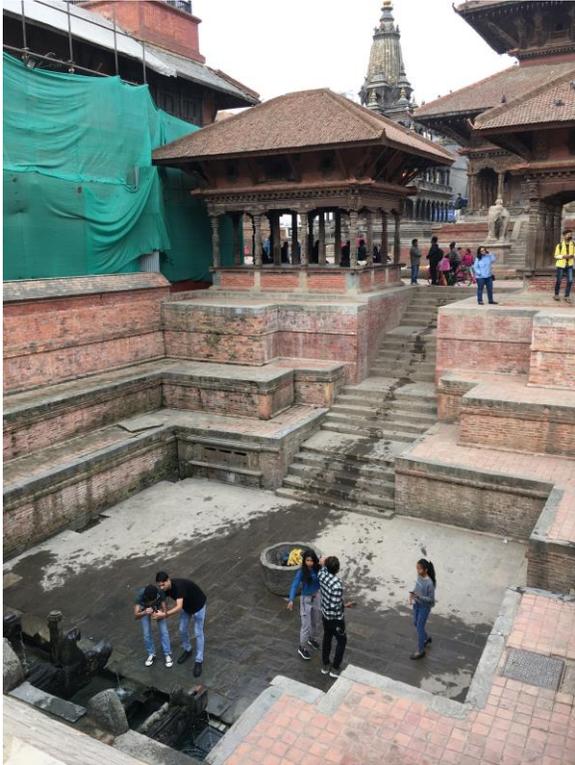
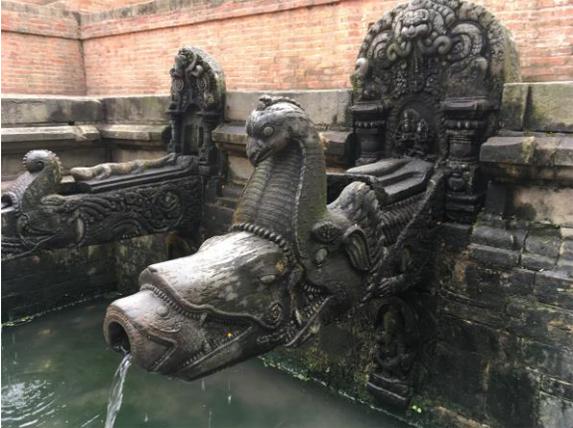
Appendix A - Manga Hiti

This three tiered Hiti consisted of three spouts all of which were observed to be consistently flowing at a relatively low flow rate and appeared to be kept in a clean condition. The drainage channel under the spouts seemed clean (comparatively to other Hitis), with water successfully flowing out of the Hiti via a drainage channel.

Users of the Hiti were observed to be collecting water for drinking purposes, as well as washing hands and feet prior to entering a nearby religious ceremony/event. Self-washing for hygiene purposes was not observed (likely due to its location at Patan Durbar Square World Heritage Site (WHS) with high footfall). Several women with young children entered the Hiti with the sole intention to educate them on the Hitis and their decorations, perhaps for religious or social reasons. Indeed, some users of the Hiti were observed praying to deities carved into the Hiti walls.

The water collected at Manga Hiti was generally understood to be used for cooking, drinking and sanitation purposes at home. It was learned that the majority of users rented rooms nearby rather than being homeowners themselves. In such a situation, direct access to taps or community wells is not available thus often people would buy a jar/large bottle (similar to an office water cooler) of water from a shop, then use the Hiti to refill the empty bottle once depleted. One respondent noted that the Hiti often runs dry in April before the monsoon rains arrive. It was understood that historically there was an additional spout, however this was removed approximately five to six years ago, evidence of which was noted during the visit (see the flat fronted structure with three holes in **Appendix A**).

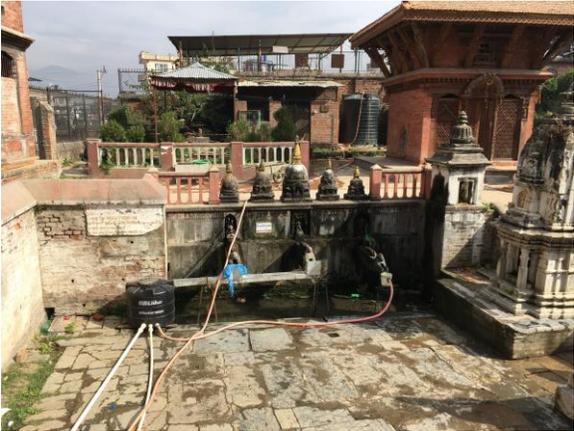
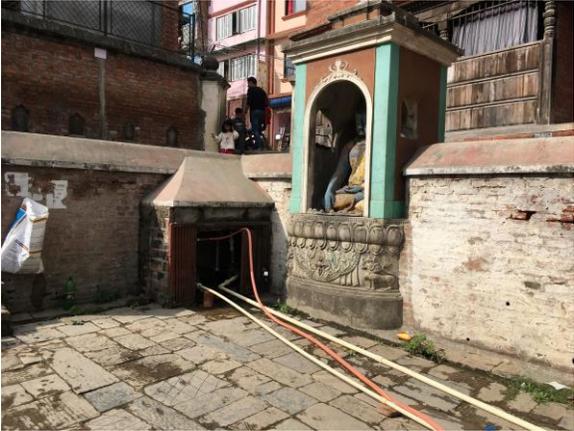
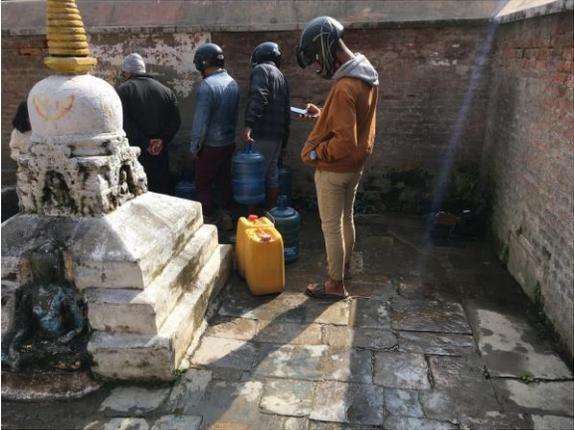
Appendix B - Alko Hiti

This small, single tiered Hiti was observed to have five spouts, all of which were functioning well with a high and consistent flow rate. Interestingly, flow from three of the five spouts was being collected and diverted into a series of large containers within the bounds of the Hiti curtilage. Alko Hiti is located in a quiet residential area, and no observations were made of the space being used for social purposes.

Given the limited size of the Hiti, the number and size of religious items/deities either standing within the Hiti or carved into the surrounding walls was both surprising and impressive. Evidence of brightly coloured paint was noted on and surrounding the deities, thus it was

As mentioned in the observation section, water was being diverted into large storage tanks. During the interview process, an Alko Hiti committee member (with a remit of approximately 1km from the Hiti) was interviewed concurrently with an informed and interested local resident. Through this, it was understood that that the tanked water (capacity of 22,000 litres) was then being piped to approximately 200 nearby homes. For this service, each household pays 7,000 rupees to register their property on the piped system, followed by a monthly tariff of 250 rupees. In the respondent's 18 years of committee membership, a similar supply system to the local area has been in place and apart from seasonal fluctuation, no change in flow rate had been noted.

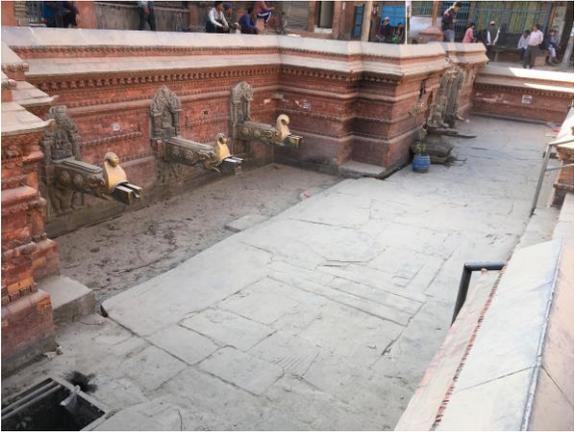
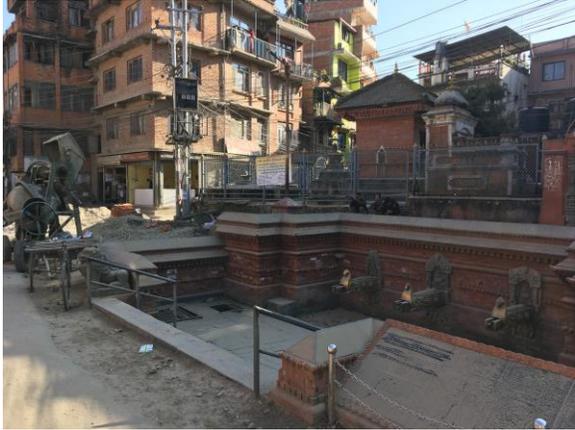
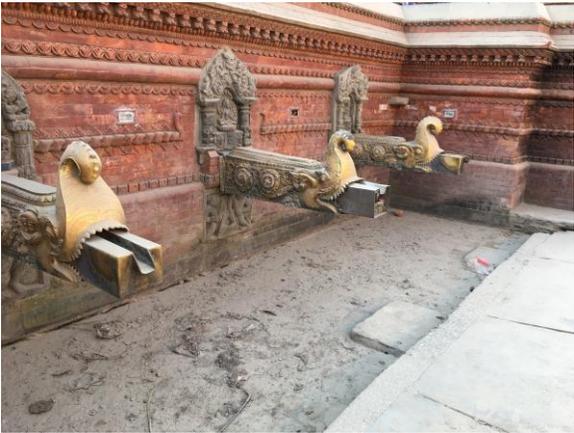
Appendix C - Sundara (Lu) Hiti

This small Hiti was a small rectangular (as opposed to square as with all other Hitis) space adjacent to a busy road. Of the four spouts evident, none were flowing and given the level of dust surrounding the spout bases it was assumed that these had been dry for a considerable length of time. The Sundara Hiti was noticeably more ornate than others, with detailed carvings in the surrounding walls and a gold finish to the spouts themselves.

A large stone slab was located at the front of the Hiti which, along with the decoration, would suggest this Hiti has a high level of cultural or religious significance despite its lack of water supply. An informal conversation between the reporter and a member of the public identified that the Hiti was around 1,000 years old and renovated in 2011.

There was a significant amount of construction work and newer tall buildings surrounding the Hiti which may well have had an influence in the lack of water supply. Members of the public were observed to sit around the Hiti, however not within the Hiti itself perhaps due to its smaller size.

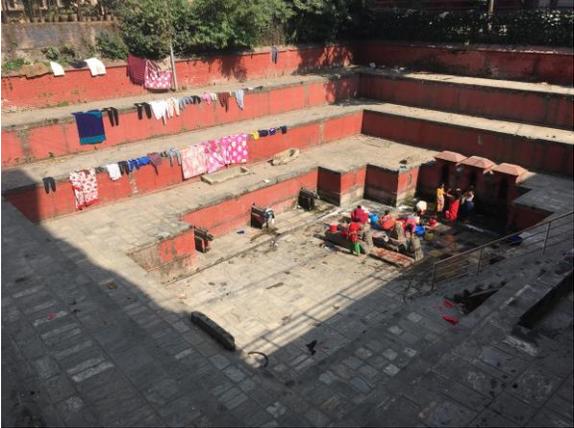
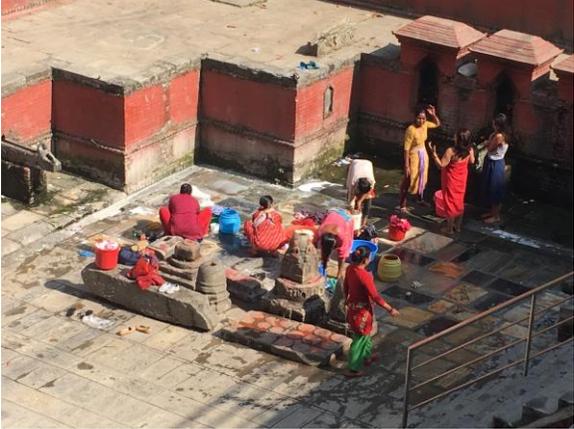
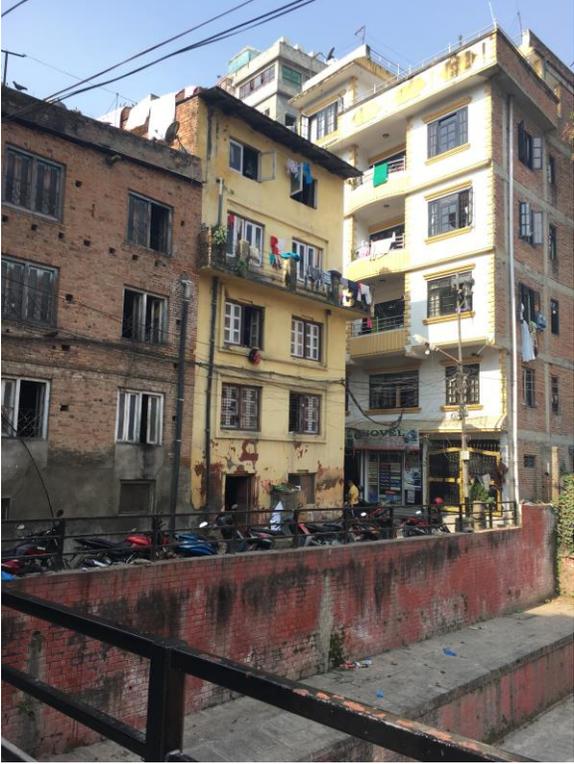
Appendix D - Ga Hiti

This Hiti was significantly larger than other Hitis in the study with four deep tiers. Of the five spouts visible only one was functioning, which had a good level of flow. Under the operational spout, a large amount of stagnant 'grey' water was noticeable. This left a large volume of scum sitting in the drainage channel which did not flow to the outlet.

Predominant uses observed consisted of washing clothes, collecting water for drinking purposes, washing for personal hygiene and socialising. Upon each visit to the Hiti, a large number of users was noted (around 11 people), however due to people washing themselves in the water, the reporter was unable to enter the Hiti properly. The surrounding tiers, while littered and overgrown with plants in some places, had been swept up previously as evidence of piles of leaves were observed.

In the centre of the Hiti were some religious items, one of which has stone disks in front each with orange powder on representing the Hiti's use for religious purposes. It was therefore assumed that regular religious activity takes place.

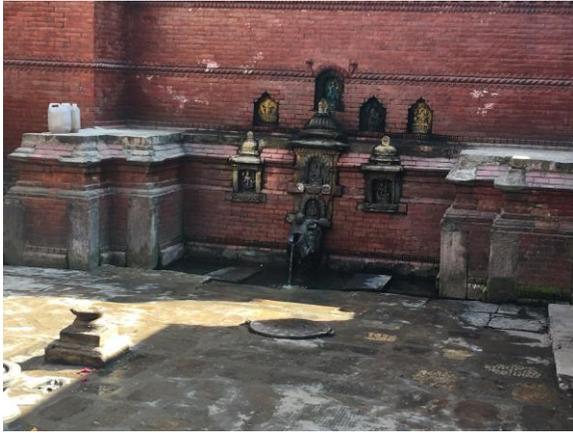
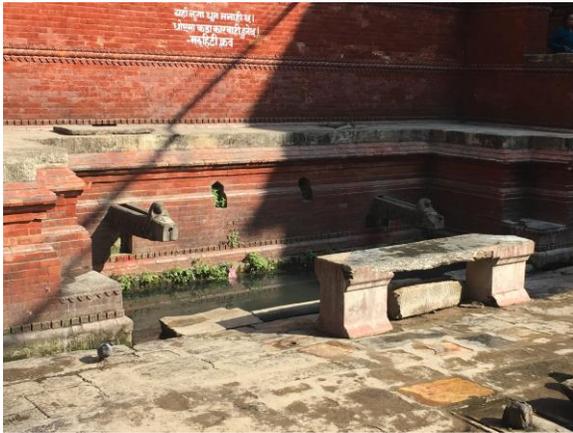
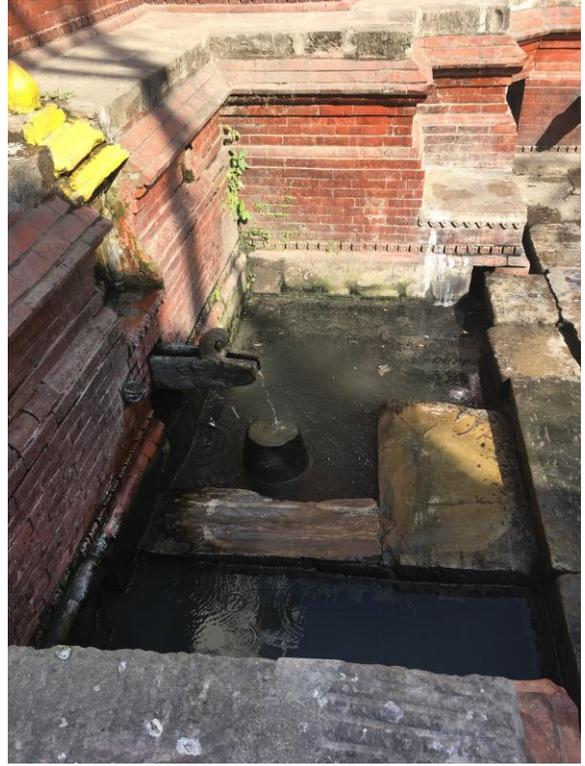
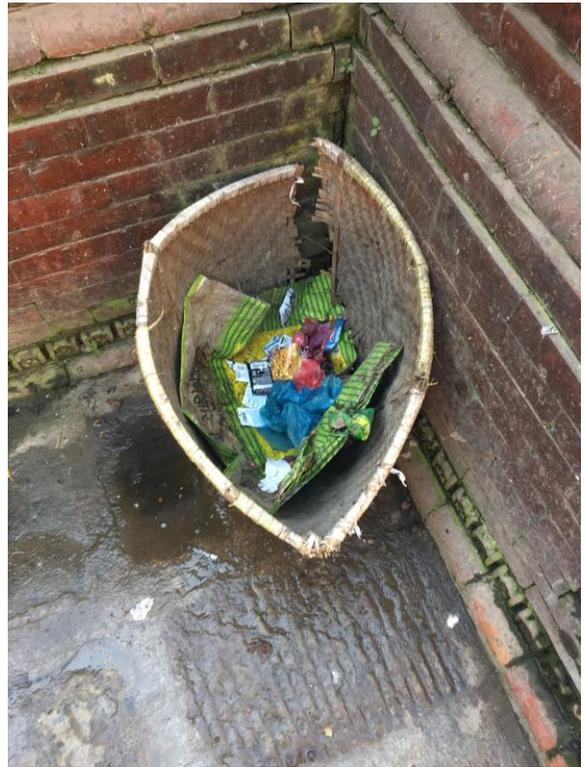
Appendix E - Maru Hiti

Of the five spouts evident at this Hiti only two were flowing, identified as having a low flow rate. Overall this was a small Hiti with a tight single tier and less ornate spouts than others. Uses of the water here were for drinking, washing for hygiene and washing clothes. This Hiti was the first observed which had a bin, actively being used by people discarding their plastic shampoo sachets. One user allowed her child to urinate in a corner adjacent to an active spout.

On the eastern side of the Hiti, drainage water was clear with seemingly good drainage flow, whilst on the western side the drainage water was cloudy with a layer of dark scum on the surface.

Again, religious items were evident at the Hiti however there were no signs that it was actively used for worshipping purposes.
